### **Influence of optical fiber coating damage in the light transmissivity characteristics of microbend sensors**

# Influence of optical fiber coating damage in the light transmissivity characteristics of microbend sensors

Franz Campero<sup>1a</sup>, Paul Cosentino<sup>a</sup>, David Fleming<sup>a</sup>, Edward Kalajian<sup>a</sup>, and Barry Grossman<sup>a</sup>  
<sup>a</sup>Florida Institute of Technology, 150 W. University Blvd., Melbourne, FL, USA

**Keywords:** Optical fiber; coating; delamination; fracture; microbending; finite element analysis; Fluortex<sup>®</sup> ETFE

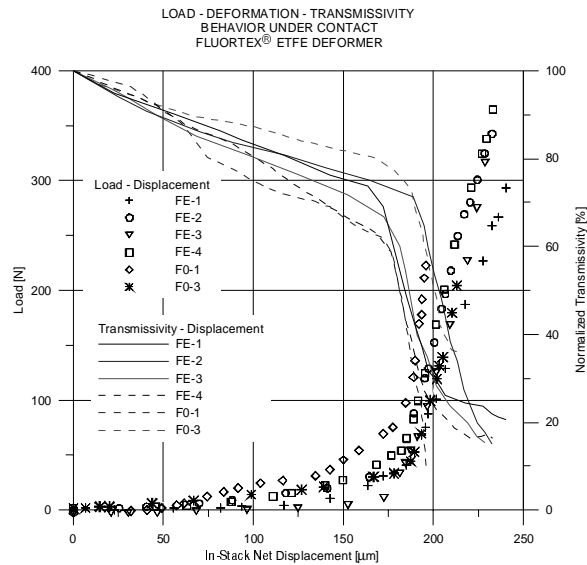
**Figure 4.** Load-displacement-transmissivity curves of six one-strand sensors tested with 250- $\mu\text{m}$  diameter Fluortex<sup>®</sup> ETFE deformer under contact.

A noticeable change of slope in the light transmissivity vs. displacement curves was observed to occur at loads similar to coating fracture loads determined during the mechanical testing phase (between 35 and 45 N). All tests were performed at constant room temperature (23 °C). In an attempt to determine the cause of variability observed in the results, and because temperature and strain rate typically influence the fracture characteristics of materials,

test speed was controlled by carefully monitoring the displacement rate of the moving platen. It was observed that the transmissivity decreased linearly up to about 60 to 70 % where a noticeable change in its curve slope occurred. After this abrupt change of slope, the transmissivity curves continued decreasing linearly with load increments until the test was stopped. Figure 4 presents the load-displacement-transmissivity curves and Table 3 summarizes the results.

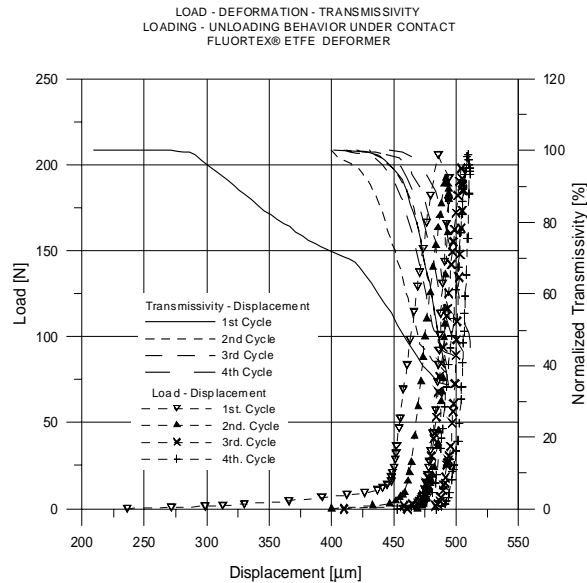
**Figure 6.** Typical loading-unloading curves for post-coating fracture peak loads.

Because of tolerance limitations in the measures of dissipated energy per cycle, cyclic testing was not conducted until constant dissipation energy values were attained. Figure 6 presents four loading-unloading cycles to peak loads greater than coating fracture loads.

The light transmissivity change of slope observed during the optical performance testing phase was present in the first loading-unloading cycle (Figure 6) but not in the subsequent cycles. This is because the coating fracture is a one-time event; therefore subsequent cycles do not present the previously observed slope change in the light transmissivity curves. Again, the energy dissipated during each cycle was determined by numerical integration and is presented in Table 6. Table 7 presents displacements registered for elastic, viscoelastic and irreversible behaviors for each cycle.

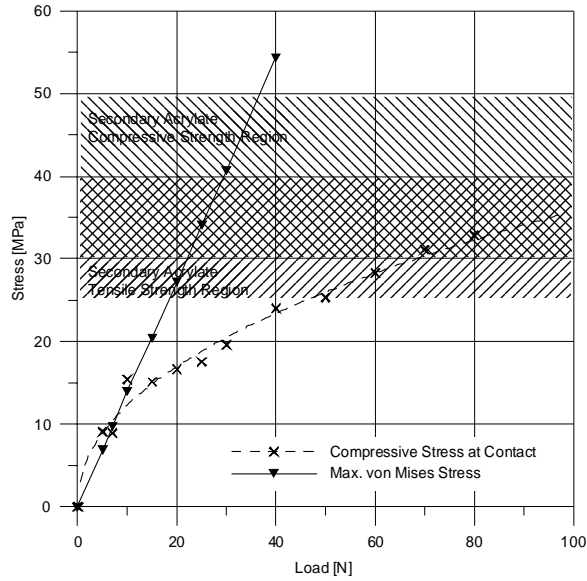
**Figure 8.** Finite Element load-stress results.

The Octahedral Shear Stress Yield was the adopted coating failure criterion. Result from the models showed that maximum stresses were developed at the inner surface of the secondary coating. Other important stresses were those developed at the contact region. Model results were plotted as load-stress and displacement-stress curves to assist in correlating model results to experimental results. Figures 8 and 9 show these curves.

Loads and displacements predicted by the Finite Element models were similar to those observed experimentally when using the maximum reported coating tensile strength (40 MPa). Table 8 summarizes experimental and numerical models results.

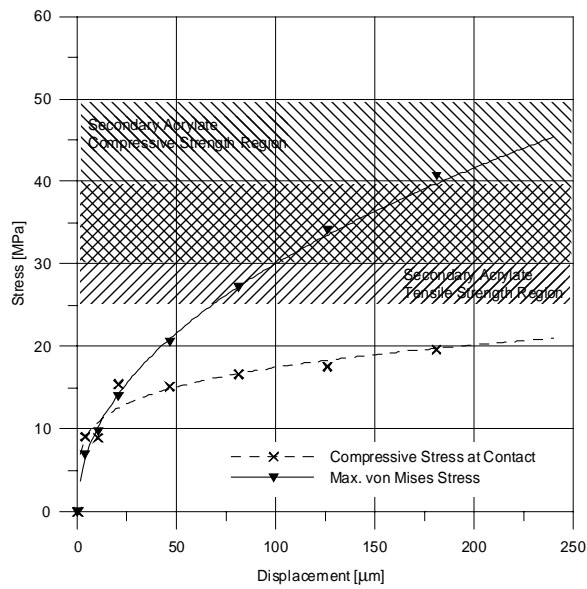
**Figure 9.** Finite Element displacement-stress results.
